Hazardous 3rd Party Modified Circuit Breakers

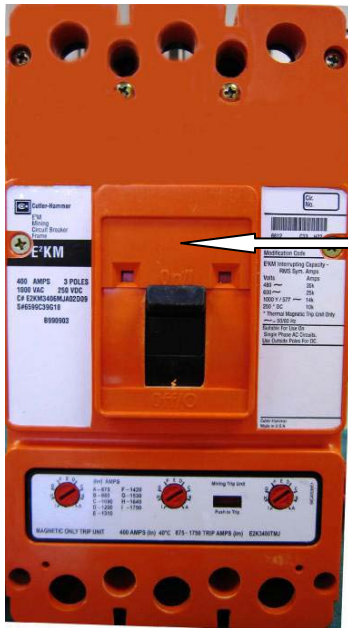
The simplest way to determine if you have one of these circuit breakers installed or in your supply house is to run your finger nail down the square portion of the cover where the circuit breaker handle is installed (See illustration below). If the cover is very smooth in this area, you probably have one of the hazardous circuit breakers. If the circuit breaker is in use, it must be removed from service. After the breaker has been removed or if a breaker is found in supply, contact Mr. Tom Grace of Eaton/Cutler-Hammer at 412-418-2169 for further instructions on how to dispose of the breaker. You may also contact Mr. Grace by email at tomagrace@eaton.com.

Scratch Here
With
Fingernail

As an interim precaution, until the breakers can be replaced, all affected breakers that trip due to any possible fault condition will require a certified electrician to test the cable with a meter for ground faults or phase to phase faults. All faults will be corrected prior to resetting the breaker. If no faults are detected with the meter or after all faults are corrected, the electrician should move to the side of the breaker and wear work gloves which are in good condition before attempting to reset the breaker. All other personnel who energize or deenergize these circuit breakers during normal use should also wear work gloves which are in good condition while performing these duties. Mine operators should inform miners of the hazards involved with these breakers and instruct all unauthorized miners to avoid travel in areas where these breakers are located.
